## FIELD INSPECTION REPORT

<b>Project Name:</b>	Mountain Valley Pipeline	<b>Inspector:</b>	Matthew Grant
<b>Inspection Date:</b>	Thursday, July 9, 2020	<b>Project Contact:</b>	Brian Clauto
<b>Spread I: Franklin</b>	MP 269.1- 269.2 MP269.4- 269.6 MP277.3-227.4 ATWS 524B, 350, 351A, 351, 693 AR-FR311, 32	<b>Weather:</b>	Dry

## FIELD INSPECTION PHOTO LOG

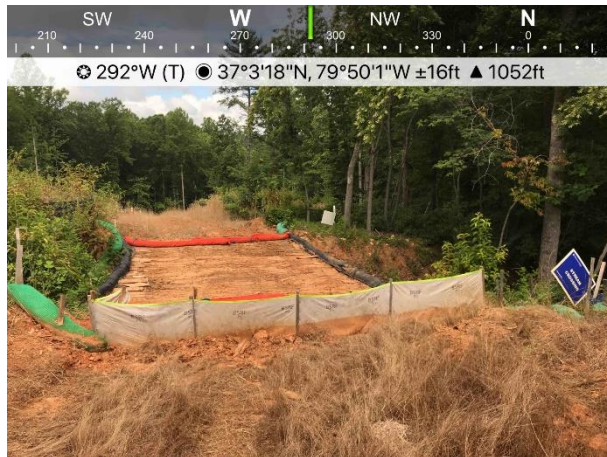
- Figure 1: At designated stream S-C20, ECDs are in place.

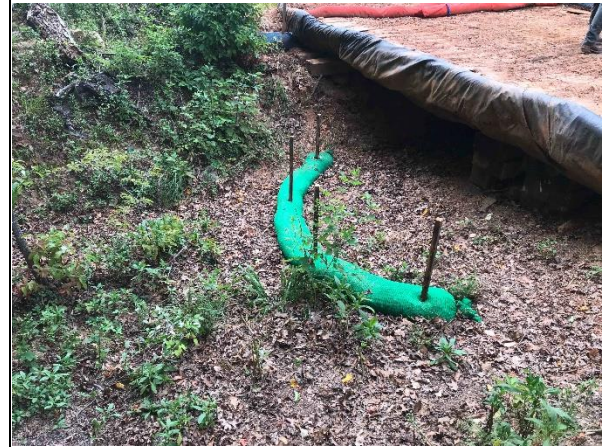
- Figure 2: At designated stream S-C20, escaped sediment has been removed.

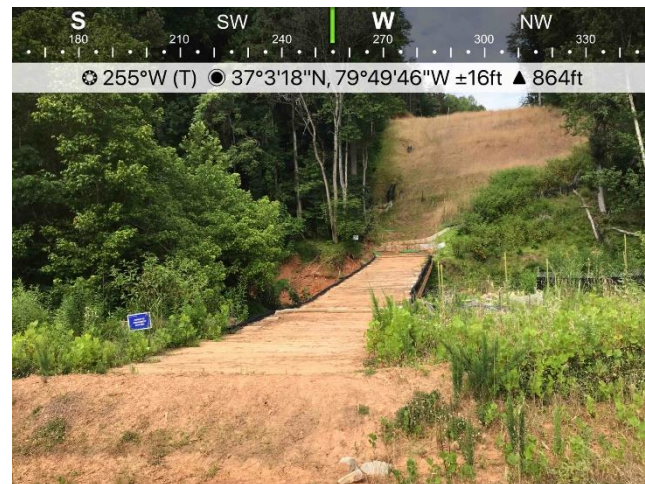
- Figure 3: Designated crossing S-C19, ECD's are in place.

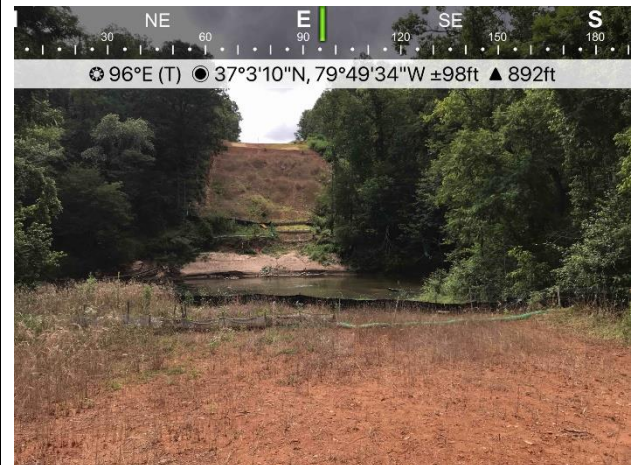
- Figure 4: Designated crossing S-F11, ECD's are in place
